cape la croix trail

master plan • city council presentation

TRAIL MASTER PLAN RECOMMENDATIONS

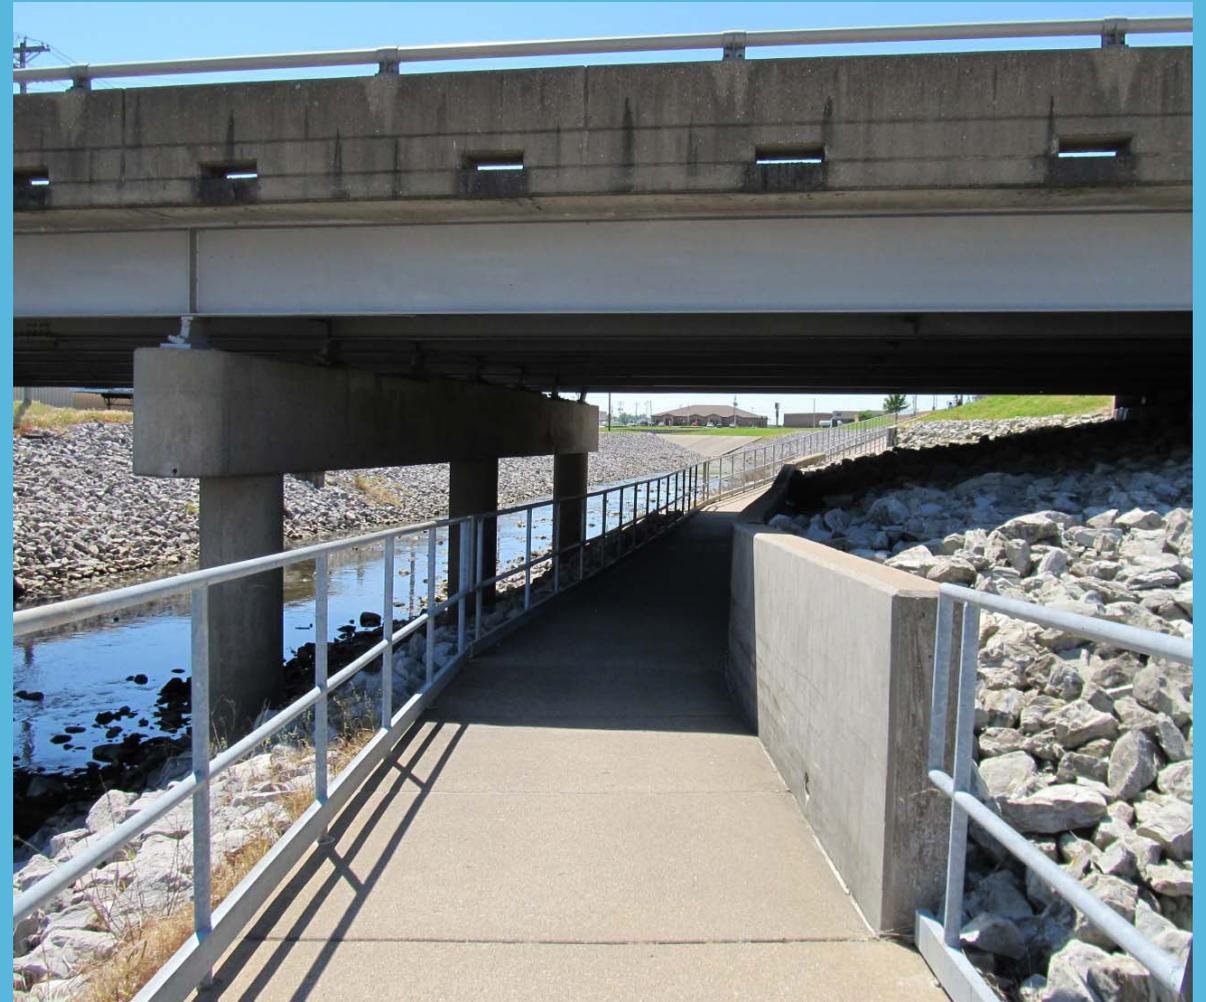
existing conditions analysis

Analysis revealed the following:

■ Lighting:

- Generally lacking

■ Underpasses:

- Lack of adequate width
- Blind corners
- Obstacles within 2 feet of trail edge
- Hazardous safety barriers
- Lack of adequate warning signage

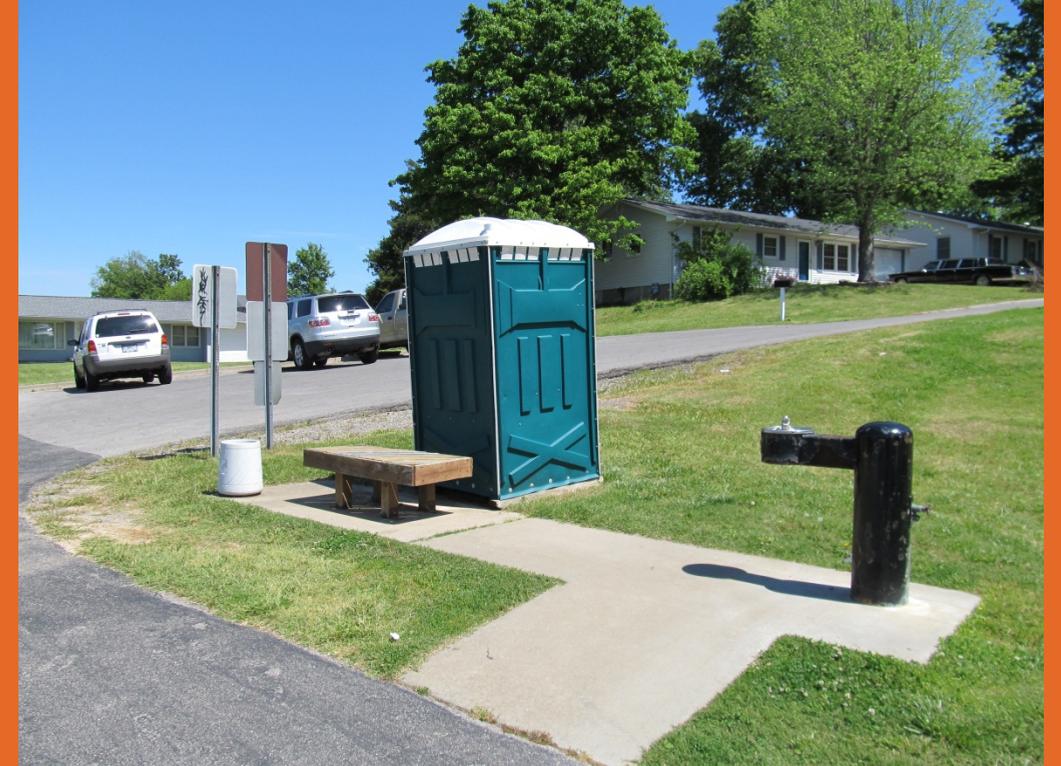
existing conditions analysis

Analysis also revealed:

Comfort Stations:

- Distributions gaps.
- Do not meet current accessibility standards.
- Portable units do not accommodate family use.
- Unheated-unavailable during winter.

Pathway Seating:

- Distributions gaps.
- Do not meet current accessibility standards.

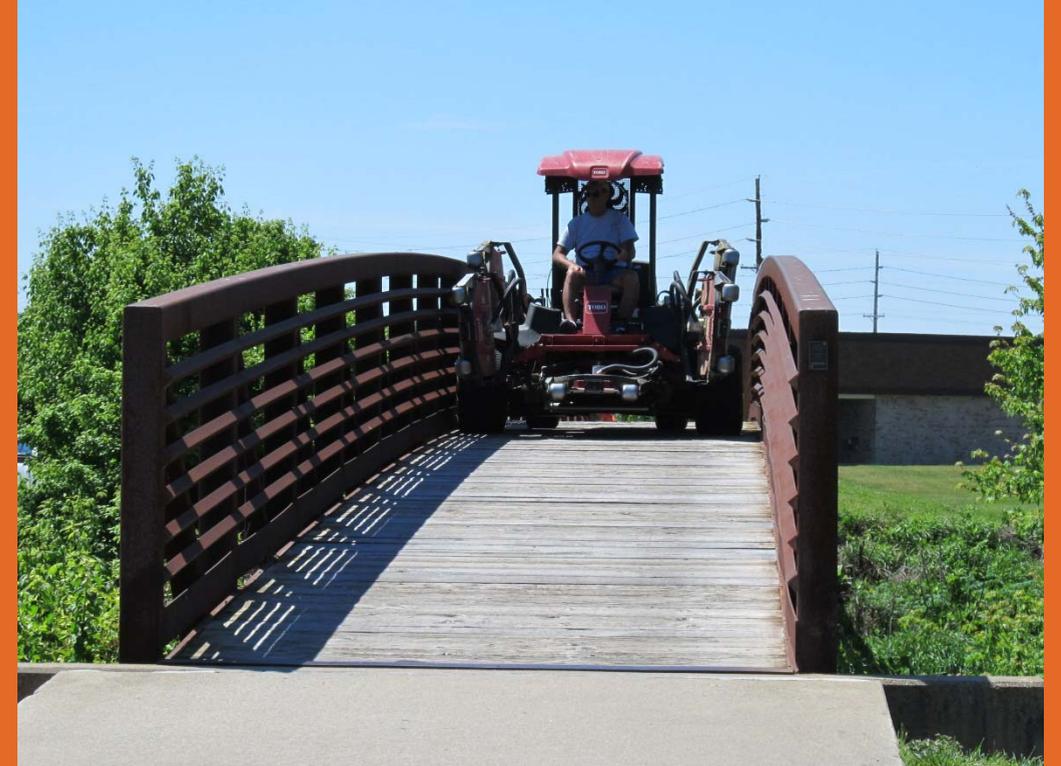
existing conditions analysis

Analysis also revealed:

Bridges:

- Inadequate min. clear width.
- Camber which exceeds current accessibility standards.
- Lack of safety barriers at abutments.
- Alignment/Corners.

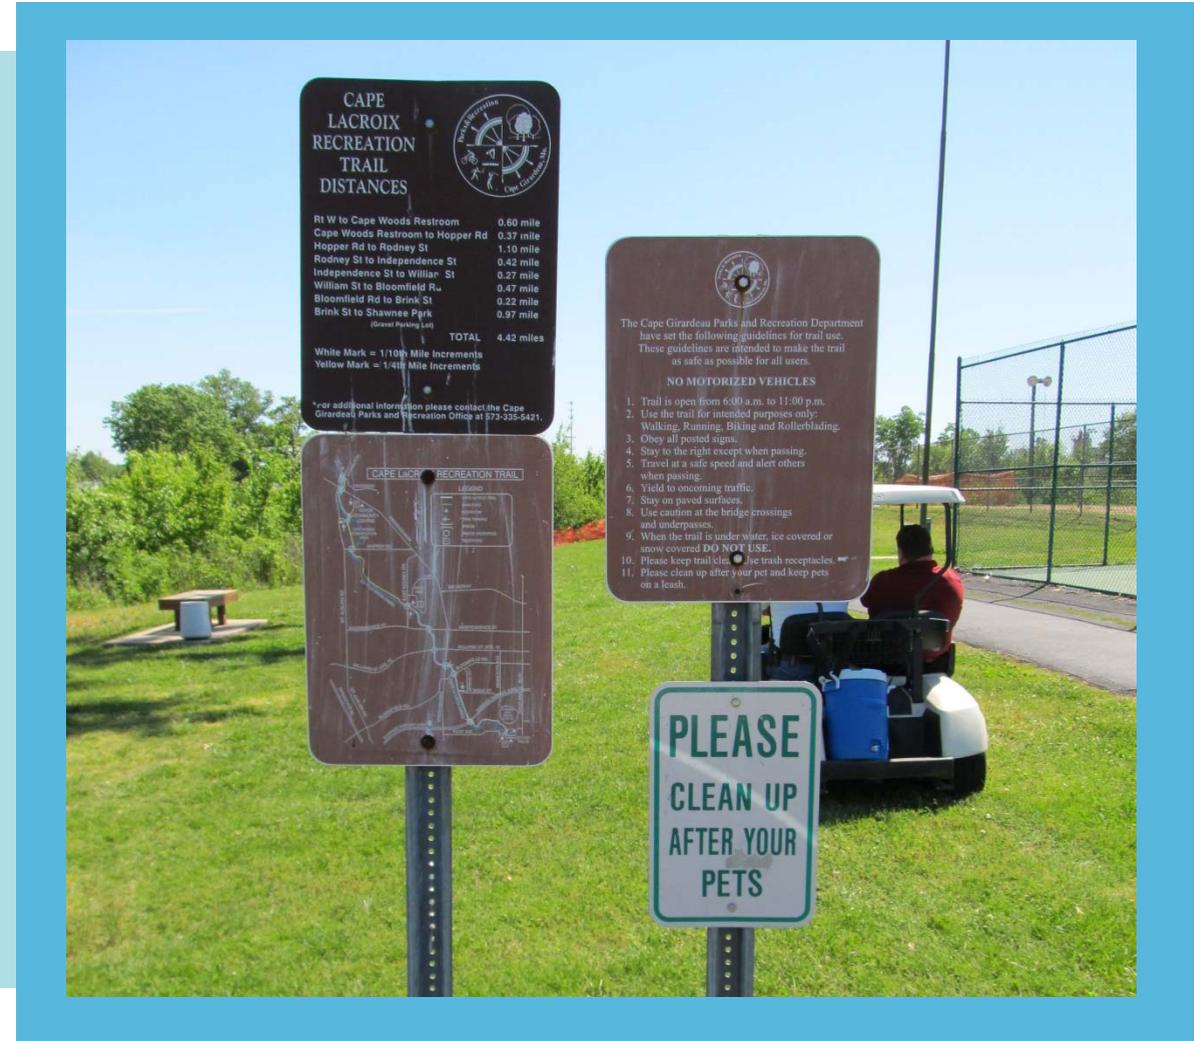
existing conditions analysis

Analysis revealed the following:

■ Signage:

- No consistent theme or unified image.
- Lack of approach/warning signs.
- Lack of signage at grade separated crossings for user orientation.
- Lack of trail rules or etiquette.
- Mile marker chaos

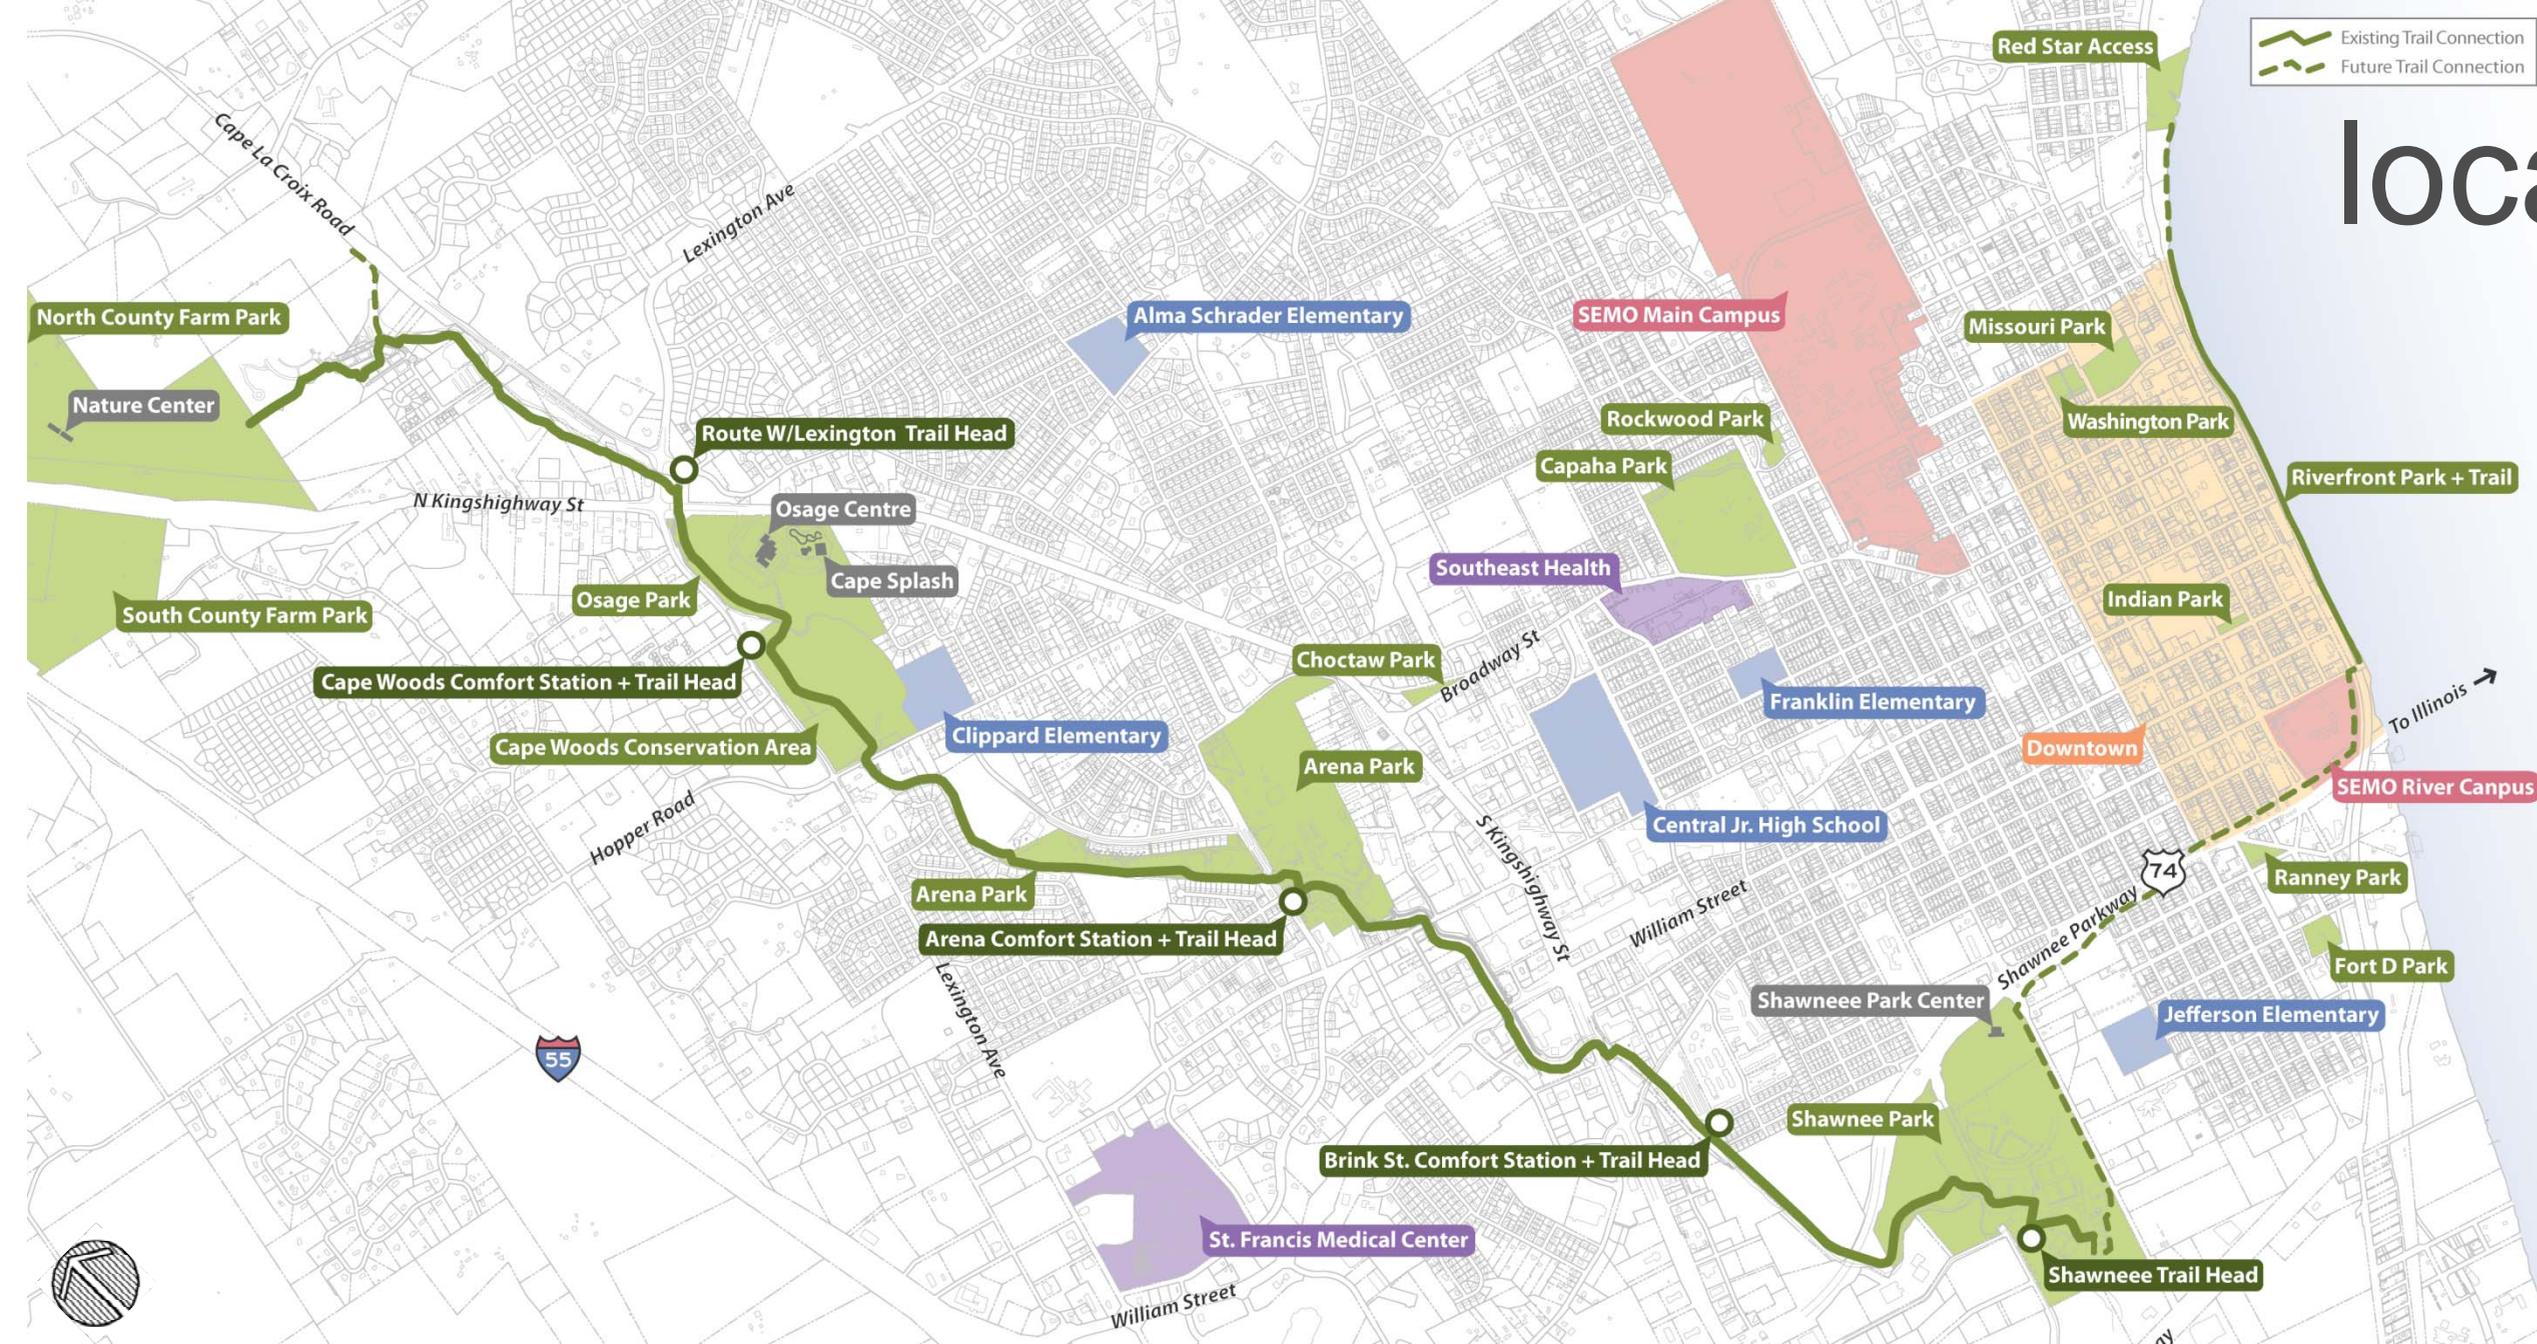
map key

sections 1 - 12

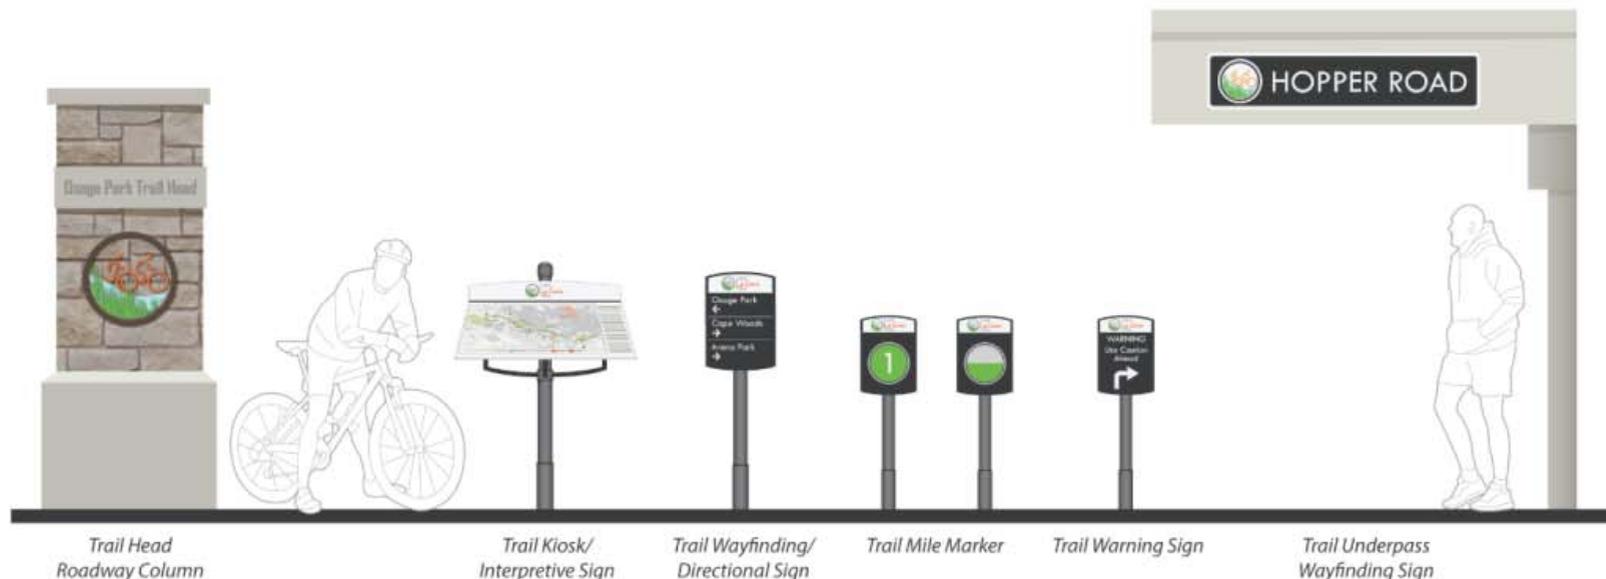
Trail Head Roadway Column

Trail Kiosk/ Interpretive Sign

Trail Wayfinding/ Directional Sign

Trail Mile Marker

Trail Warning Sign

TRAIL BRANDING

Trail Head Roadway Column

- A signature column is proposed to be located at each Trail Head near an adjacent roadway to visually mark the Trail Head.

Trail Kiosk/Interpretive Sign

- To be installed at various locations along the Trail to provide Trail System Map on one side and an informational kiosk on the other.

Trail Wayfinding/Directional Sign

- To be installed at locations along the Trail which require signage to direct users to various destinations.

Trail Mile Marker

- A full circle indicates a full mile interval, and a half-filled circle indicates a half mile interval. To be located on both sides of Trail.

Trail Warning Sign

- To be installed at locations along the Trail to communicate a simplified warning, i.e. Warning - Blind Curve Ahead.

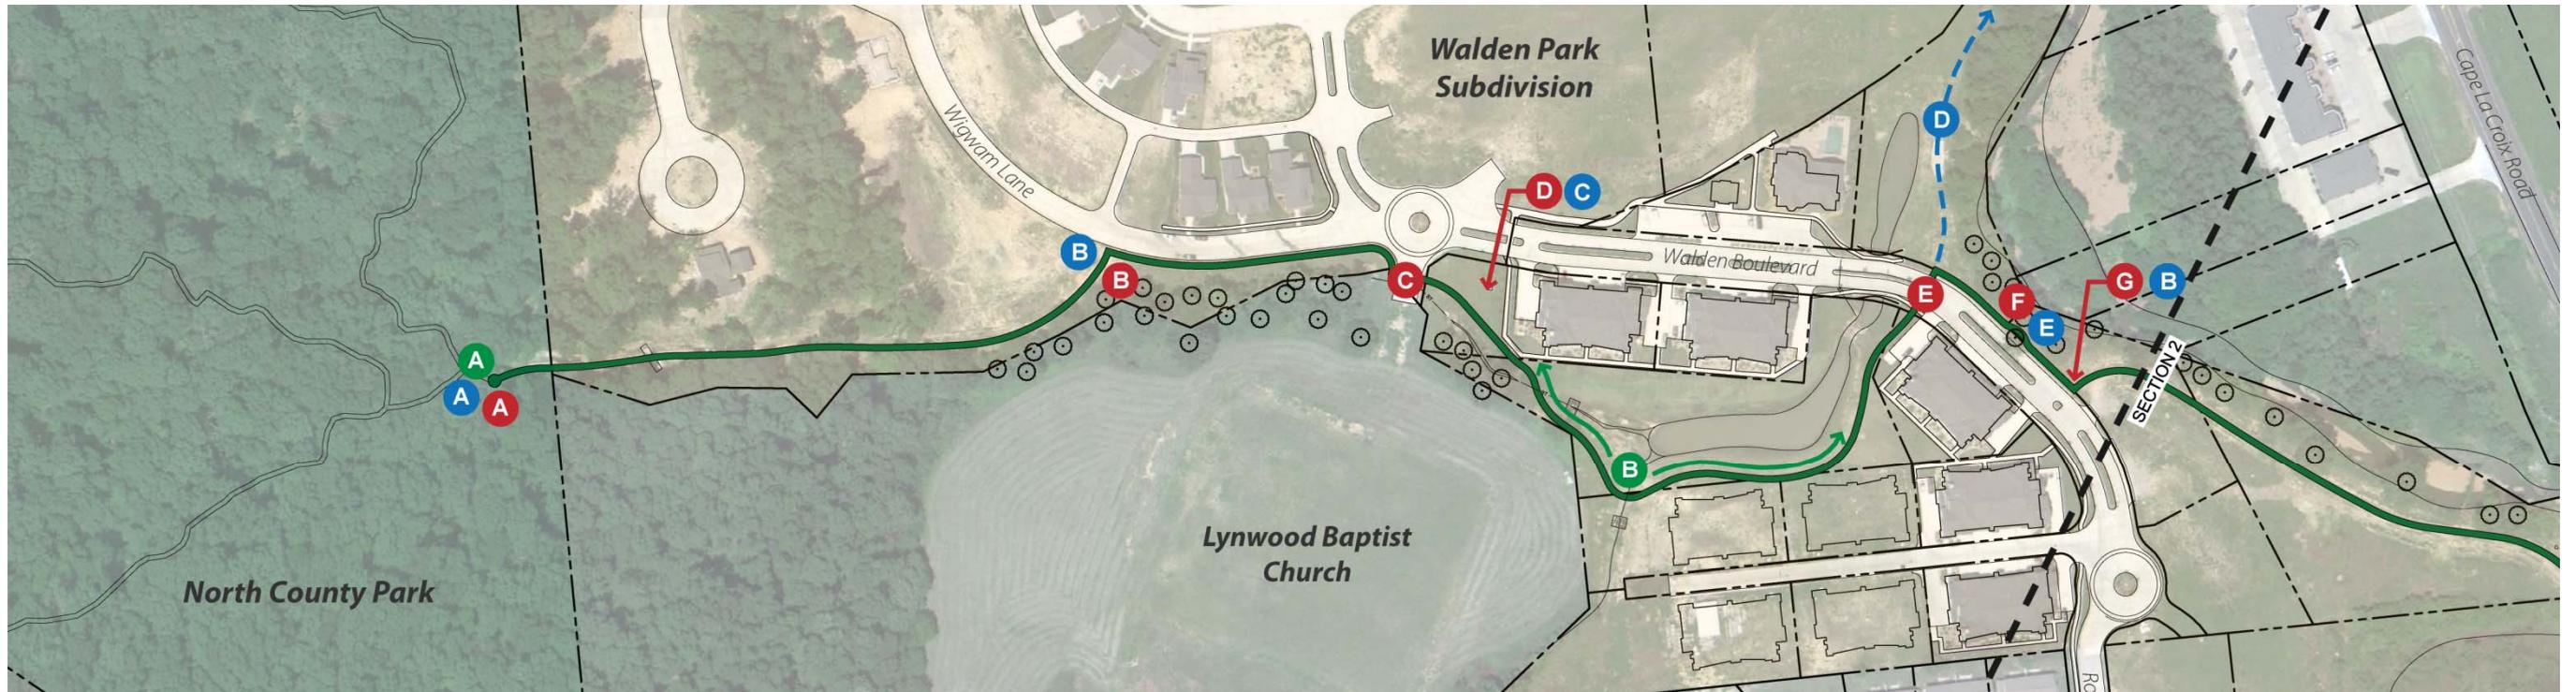
● ATTRIBUTES

- A. Bike rack, park bench, and North County Park wayfinding signage.
- B. Newest section completed to enhance connectivity through new development to North County Park and Nature Center.

- A. Supplement existing Trail Head with trail wayfinding signage/kiosk, trash receptacle and mutt mitt dispenser.
- B. Long Term Recommendation - consider trail re-alignment project to correct sub-standard horizontal curve alignment.
- C. Consider partnering with private owner to provide landscape screening of electrical transformer.
- D. Future trail connection to Route W.
- E. Add landscape plantings to screen rip-rap along trail shoulder and to improve quality of trail experience.

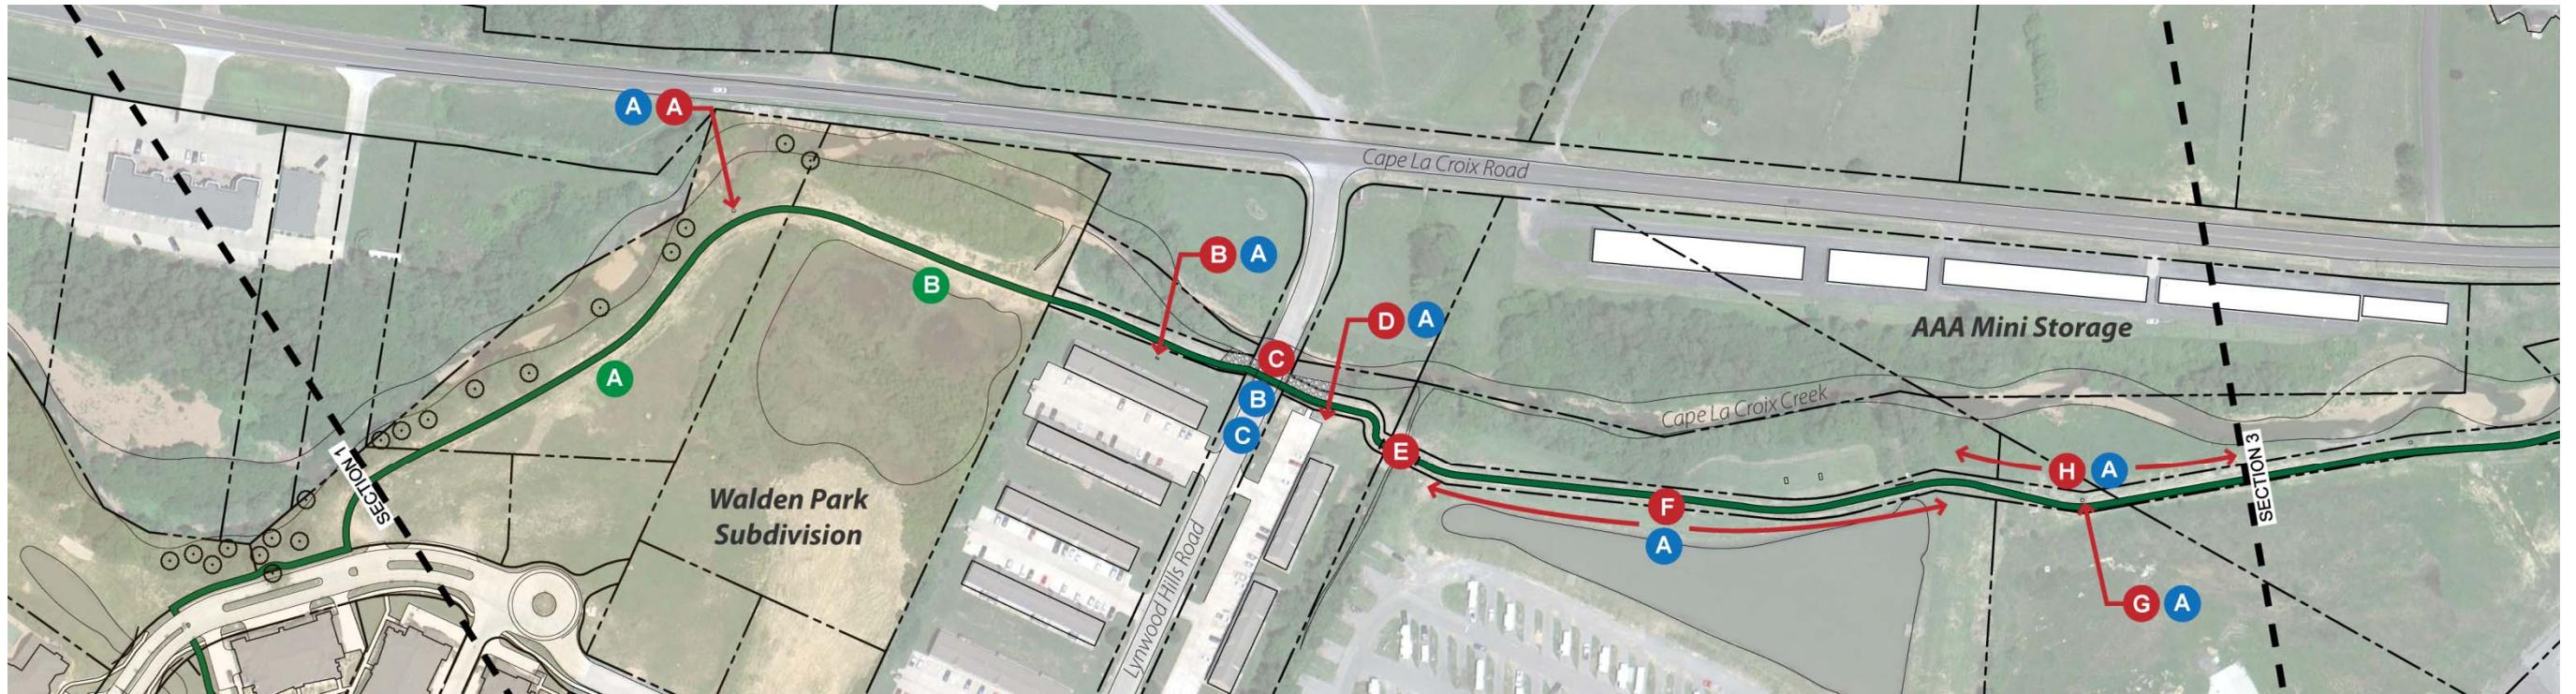
● ATTRIBUTES

- A. Prairie/native grass - potential opportunity for interpretive educational/informational signage.
- B. Wetland - potential opportunity for interpretive educational/informational signage.

- A. Add landscape plant buffer to improve quality of trail experience.
- B. Use blank concrete wall for public art opportunity. Add signage to Lynwood Hills Road bridge structure to improve orientation. Add lighting for improved perceived safety and trail experience. Provide plantings to create edge buffer at rip-rap under bridge.
- C. Add signage warning of approaching narrow bridge.

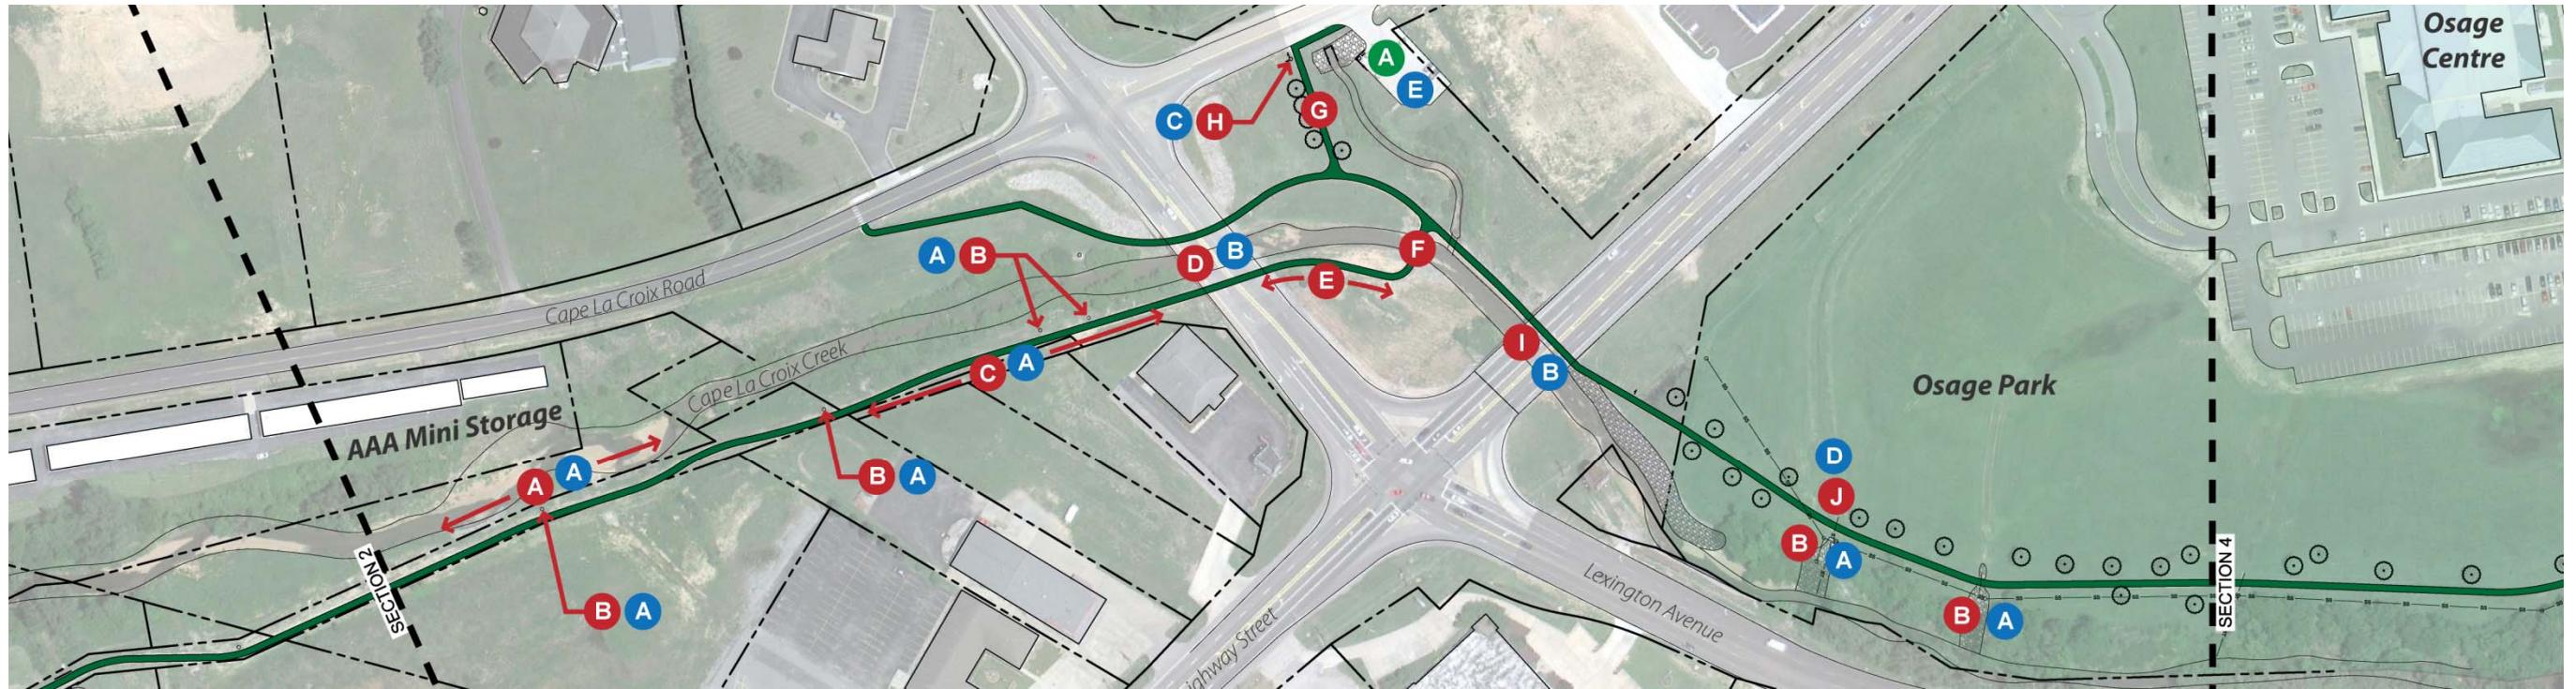
ATTRIBUTES

- A. Lexington/North Kingshighway Trail head parking lot (19 standard stalls, 0 handicap stalls), bike rack, and trash receptacle.

- A. Add landscape plant screen to improve quality of trail experience.
- B. Use blank concrete wall space for public art opportunity. Add signage for Lexington Avenue/Kingshighway Street bridge structure for improved orientation. Add lighting for improved perceived safety and trail experience.
- C. Update trail wayfinding signage.
- D. Add native landscape plantings to swale to improve ecological habitat and quality of trail experience.
- E. Consider additional amenities such as shade structure, drinking fountain, bicycle air pump, potential vending opportunity at Route W/Lexington Trail Head.

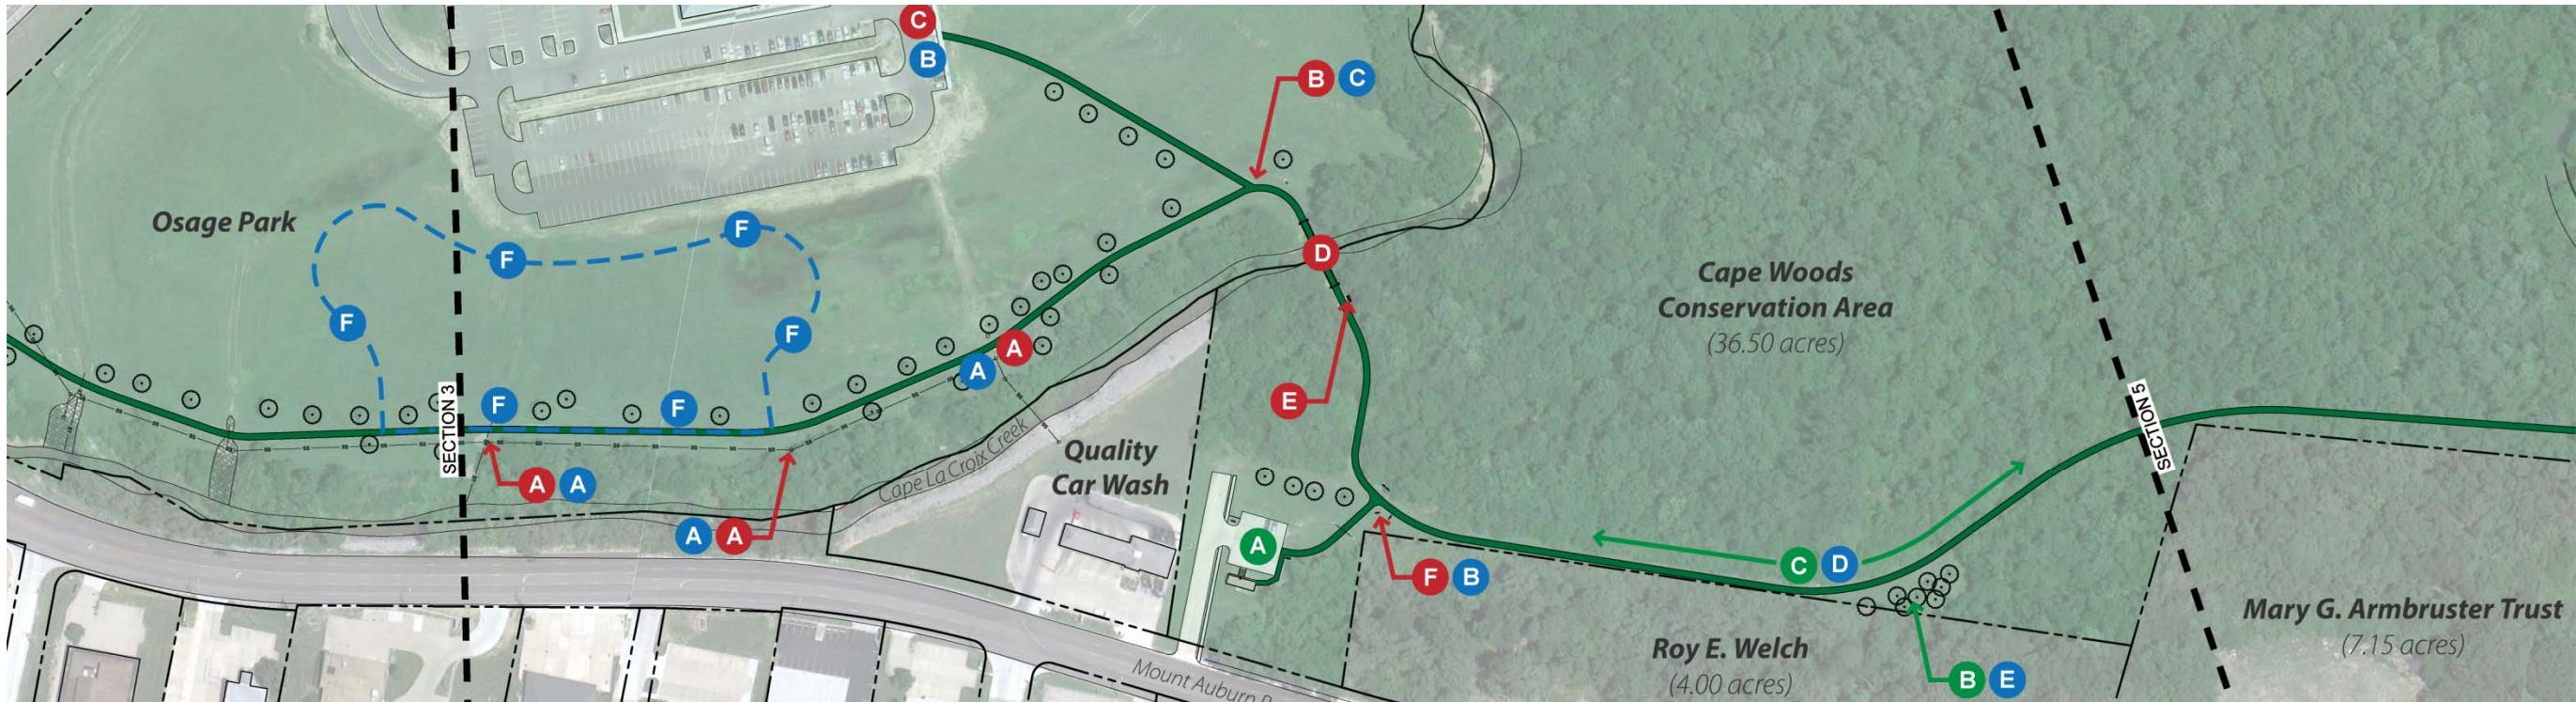
● ATTRIBUTES

- A. Cape Woods Trail head with parking lot (8 standard stalls, 2 handicap stalls), comfort station, drinking fountain, park bench, bike rack, and trash receptacle; comfort station access ramp at 6% slope exceeds maximum standard design of 5.0%.
- B. Open tree grove which creates an engaging environment.
- C. Pleasant experience through Missouri hardwood forest.

- A. Add landscape plant screen to improve quality of trail experience.
- B. Add/Update trail wayfinding signage.
- C. Re-align trail to create a safer 90 degree intersection to improve trail safety.
- D. Potential opportunity for interpretive educational/informational signage.
- E. Proposed child play node/rest stop.
- F. Proposed 1/4 mile fitness trail loop with outdoor fitness equipment.

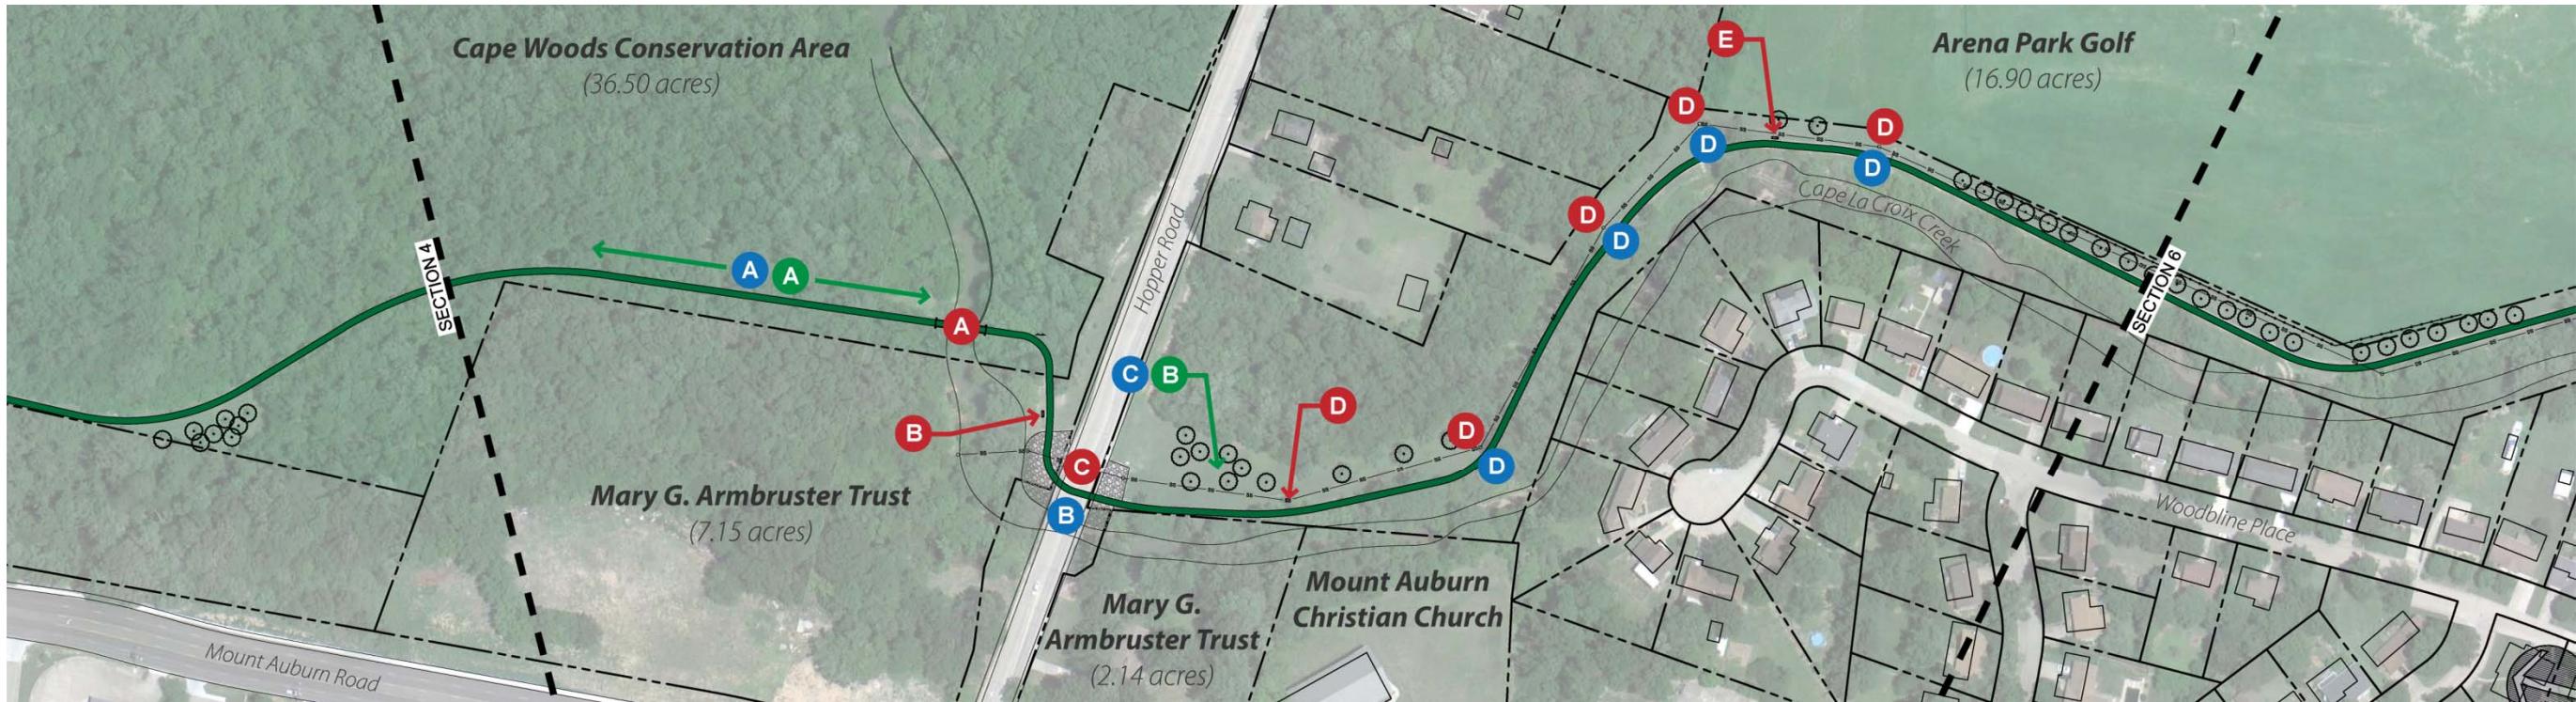
● ATTRIBUTES

- A. Pleasant experience through Missouri hardwood forest.
- B. Open tree grove which creates an engaging environment.

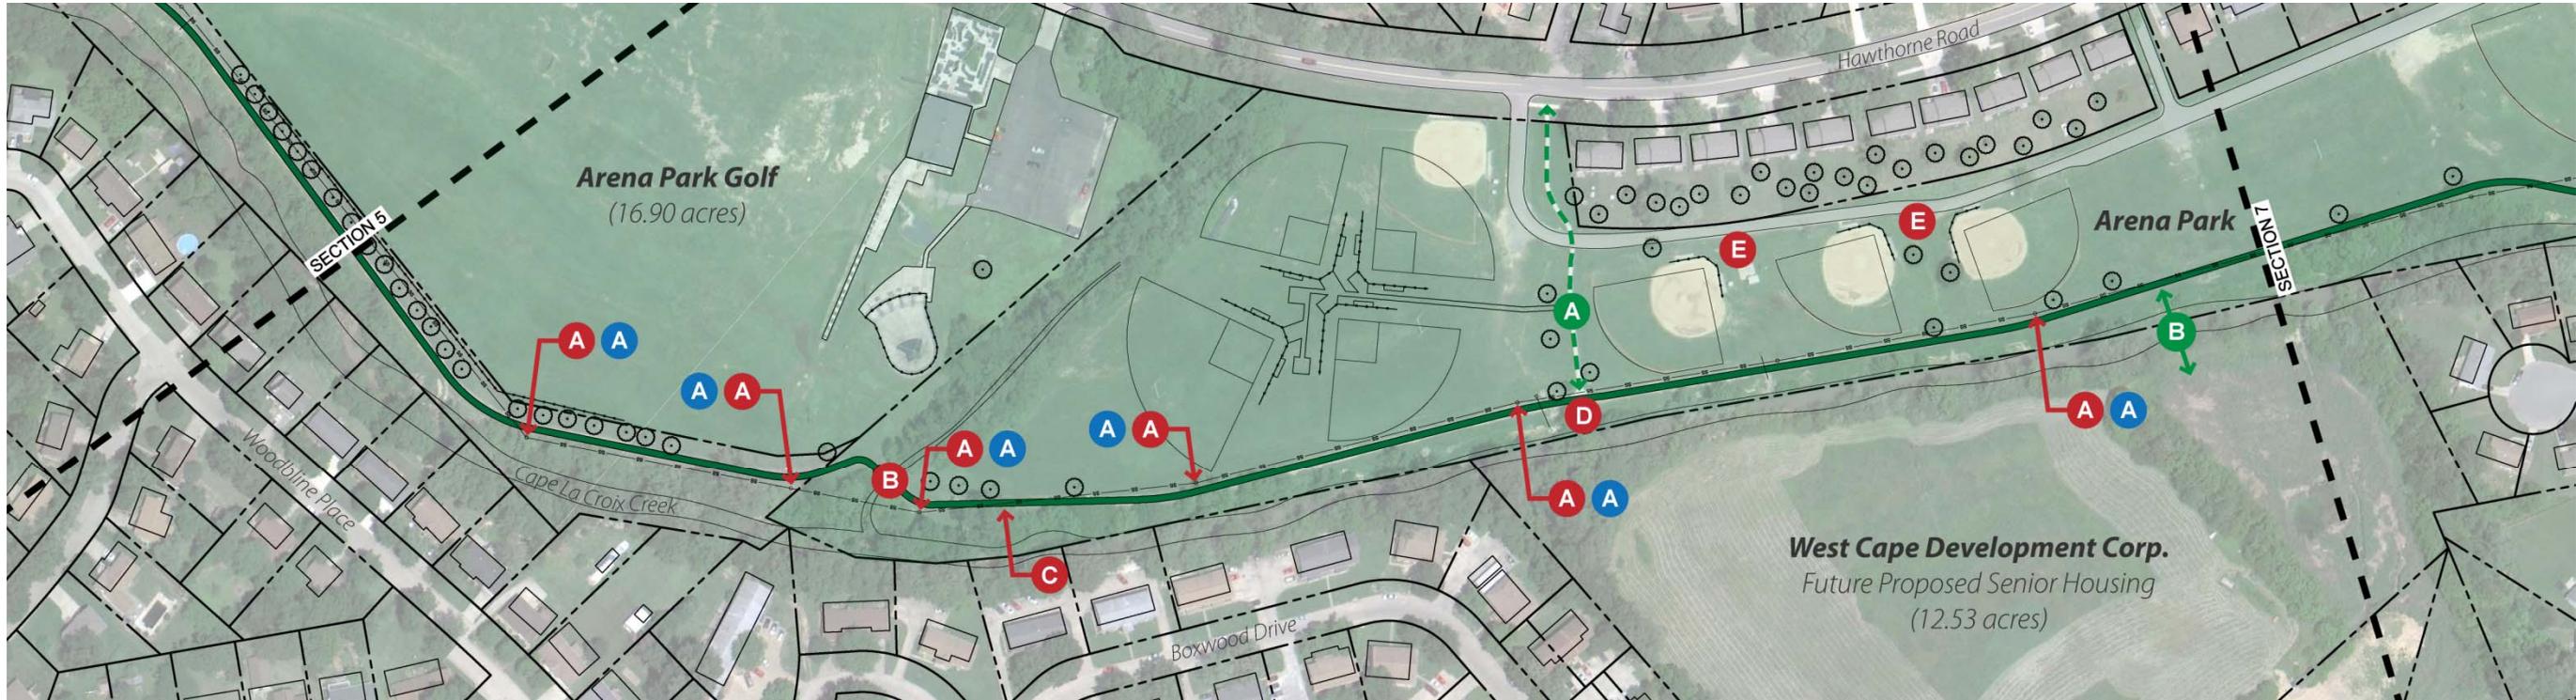
5

● ATTRIBUTES

- A. Trail connection to local neighborhood - encourages travel by foot, reduction of vehicular travel and greater use of trail.
- B. Future bridge to connect proposed Senior Housing and Arena Park.

● DEFICIENCIES

- A. Sanitary Sewer manhole structure is unattractive.
- B. Narrow 8' wide bridge structure - does not meet minimum design standard width of 12'.
- C. Outdated and non-compliant ADA park bench.
- D. Lack of wayfinding trail signage.
- E. Drinking fountain - no connection to Trail.

● RECOMMENDATIONS

- A. Add landscape plant screen to improve quality of trail experience.
 - B. Add trail wayfinding signage to improve orientation.
- Miscellaneous - Consider landscape screening between trail and sport fields to create separation of uses.

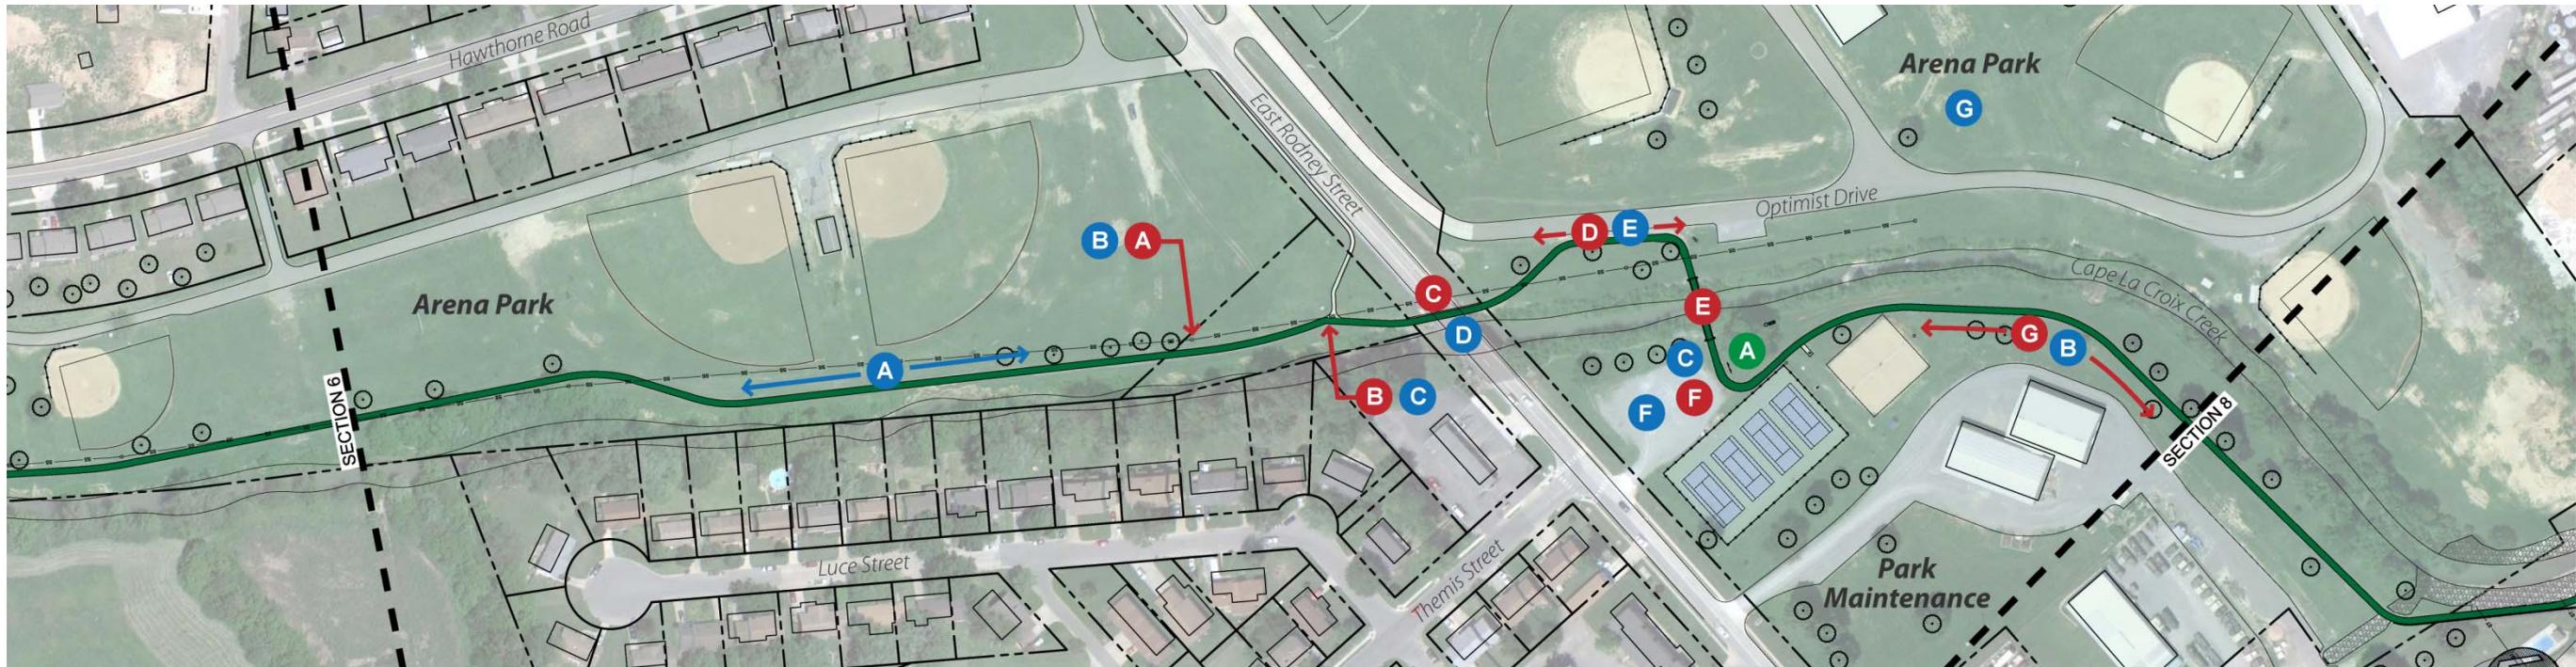
ATTRIBUTES

- A. Arena Park Trail head with gravel parking lot, drinking fountain, bike rack, non-ADA compliant park bench, trash receptacle and trail wayfinding signage.

DEFICIENCIES

- A. Sanitary Sewer manhole structure is unattractive.
- B. Lack of wayfinding trail signage.
- C. Rip-rap along trail shoulder at underpass - no safety barrier; exposed bridge under-structure is unattractive.
- D. No separation between Optimist Drive and trail - creates unsafe condition for Trail users.
- E. Narrow 8' wide bridge structure - does not meet minimum design standard width of 12'.
- F. Outdated trail wayfinding signage.
- G. Park Maintenance Facility is unattractive.

RECOMMENDATIONS

- A. Consider landscape screening between trail and sport fields to create separation of uses.
- B. Add landscape plant screen to improve quality of trail experience.
- C. Add/update trail wayfinding signage to improve orientation.
- D. Use blank concrete wall for public art opportunity. Add signage to East Rodney Street bridge structure for improved orientation. Add lighting for improved perceived safety and trail experience.
- E. Add landscape plant buffer and/or bollards to improve trail safety.
- F. Consider installing curbs and permeable pavement for parking lot.
- G. Consider internal Arena Park trail network.
