cape la croix trail

master plan • city council presentation

TRAIL MASTER PLAN RECOMMENDATIONS

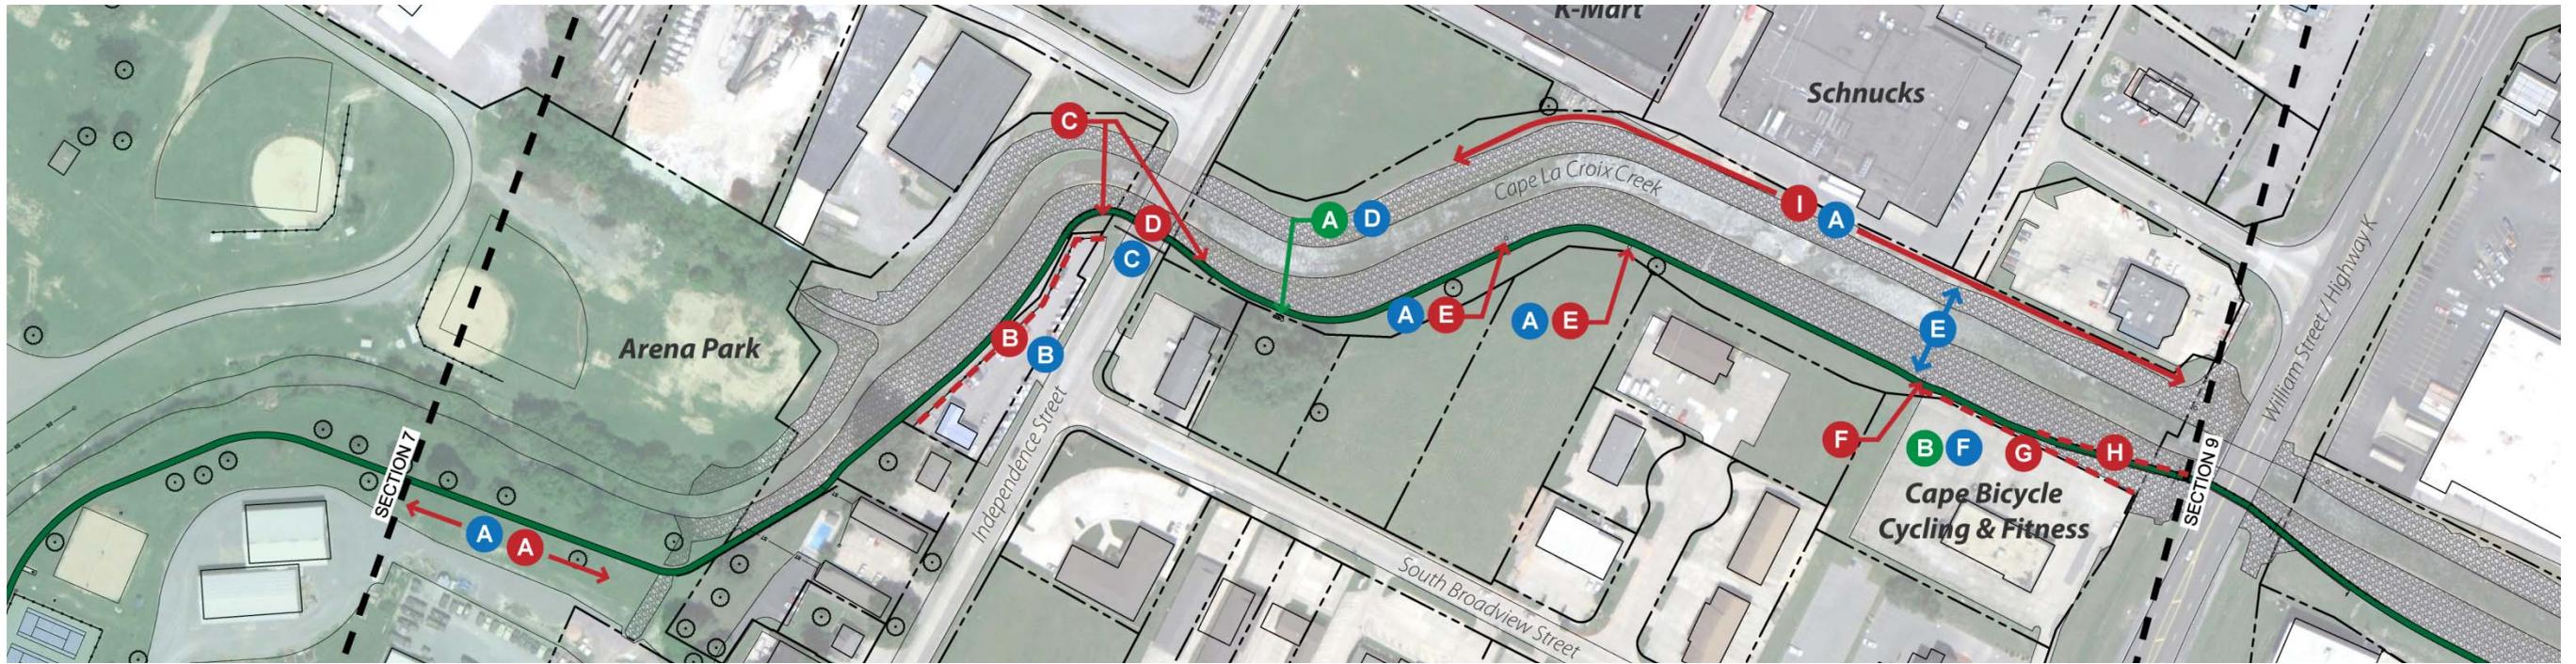
● ATTRIBUTES

- A. Rest Stop with non-ADA compliant park bench and trash receptacle.
- B. Cape Bicycle store use very compatible with Trail.

● DEFICIENCIES

- A. National Guard is unattractive.
- B. Cape Autoplex fencing is unattractive.
- C. Retaining wall - blind, tight curve; metal guardrail - exposed end segment creates safety hazard.
- D. Exposed bridge under-structure is unattractive.
- E. Sanitary Sewer manhole structure is unattractive.
- F. Sanitary Sewer manhole structure - lid grade difference creates Trail alignment issue and safety hazard.
- G. 6" concrete curb - barrier for access to Bike Shop.
- H. Metal guardrail - exposed end segment creates safety hazard.
- I. Big box store service areas are unattractive.

● OPPORTUNITIES

- A. Add landscape plant screen to improve quality of trail experience.
- B. Coordinate with owner of Cape Autoplex for alternative fencing and/or landscape screening.
- C. Use blank concrete wall for public art opportunity. Add signage on Independence Street bridge structure for improved orientation. Add lighting for improved perceived safety and trail experience.
- D. Provide ADA compliant bench at existing rest stop.
- E. Future bridge/connection to retail development.
- F. Opportunity for public/private partnership and/or future Trail Head with amenities, including vending opportunity. Partner with owner for removal of 6" concrete curb to provide access from trail.

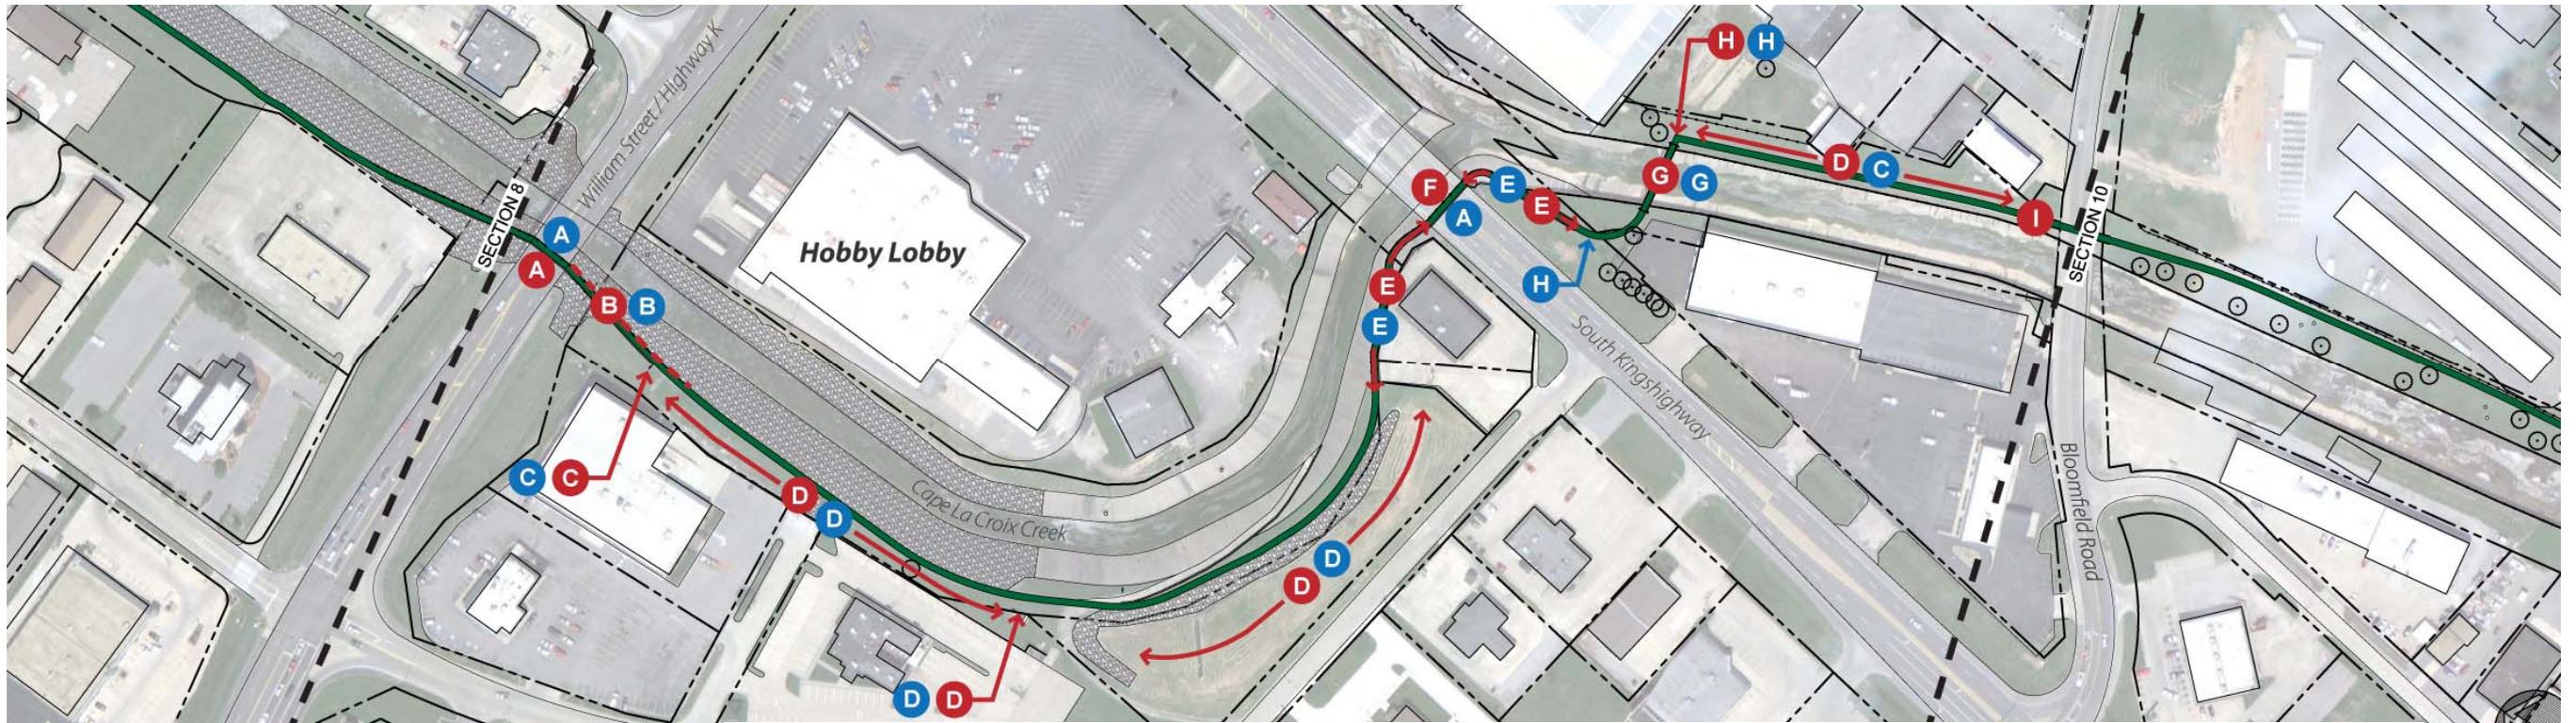
8

● DEFICIENCIES

- A. Exposed bridge under-structure is unattractive.
- B. Retaining wall - blind, tight curve; metal guardrail - exposed end segment creates safety hazard.
- C. Trail signage - outdated and non-functional.
- D. Adjacent development is unattractive.
- E. Retaining wall - blind, tight curve; metal guardrail - exposed end segment creates a safety hazard.
- F. Exposed bridge under-structure is unattractive.
- G. 8' wide bridge structure - does not meet minimum design standard width of 12'.
- H. 90 degree, sharp curve - does not meet minimum standard design radius of 60'.
- I. 6.5%+ trail slope - exceeds maximum design standard profile slope of 5.0%.

● OPPORTUNITIES

- A. Use blank concrete wall for public art opportunity. Add signage on William Street bridge structure for improved orientation. Add lighting for improved perceived safety and trail experience.
- B. Remove existing retaining wall and relocate to provide additional width and improve sight line. Replace railing with safer and bicycle-compliant style.
- C. Update trail warning signage and add permanent integrated trail surface warning system.
- D. Add landscape plant screen to improve quality of trail experience.
- E. Remove existing retaining wall and reconstruct south closer to parking area. Remove and replace metal guardrail with bicycle-compliant ornamental fencing.
- F. Provide aesthetic enhancements to bridge under-structure.
- G. Long-term replacement with 12' wide bridge structure.
- H. Provide approach warning signs for sharp curve ahead.

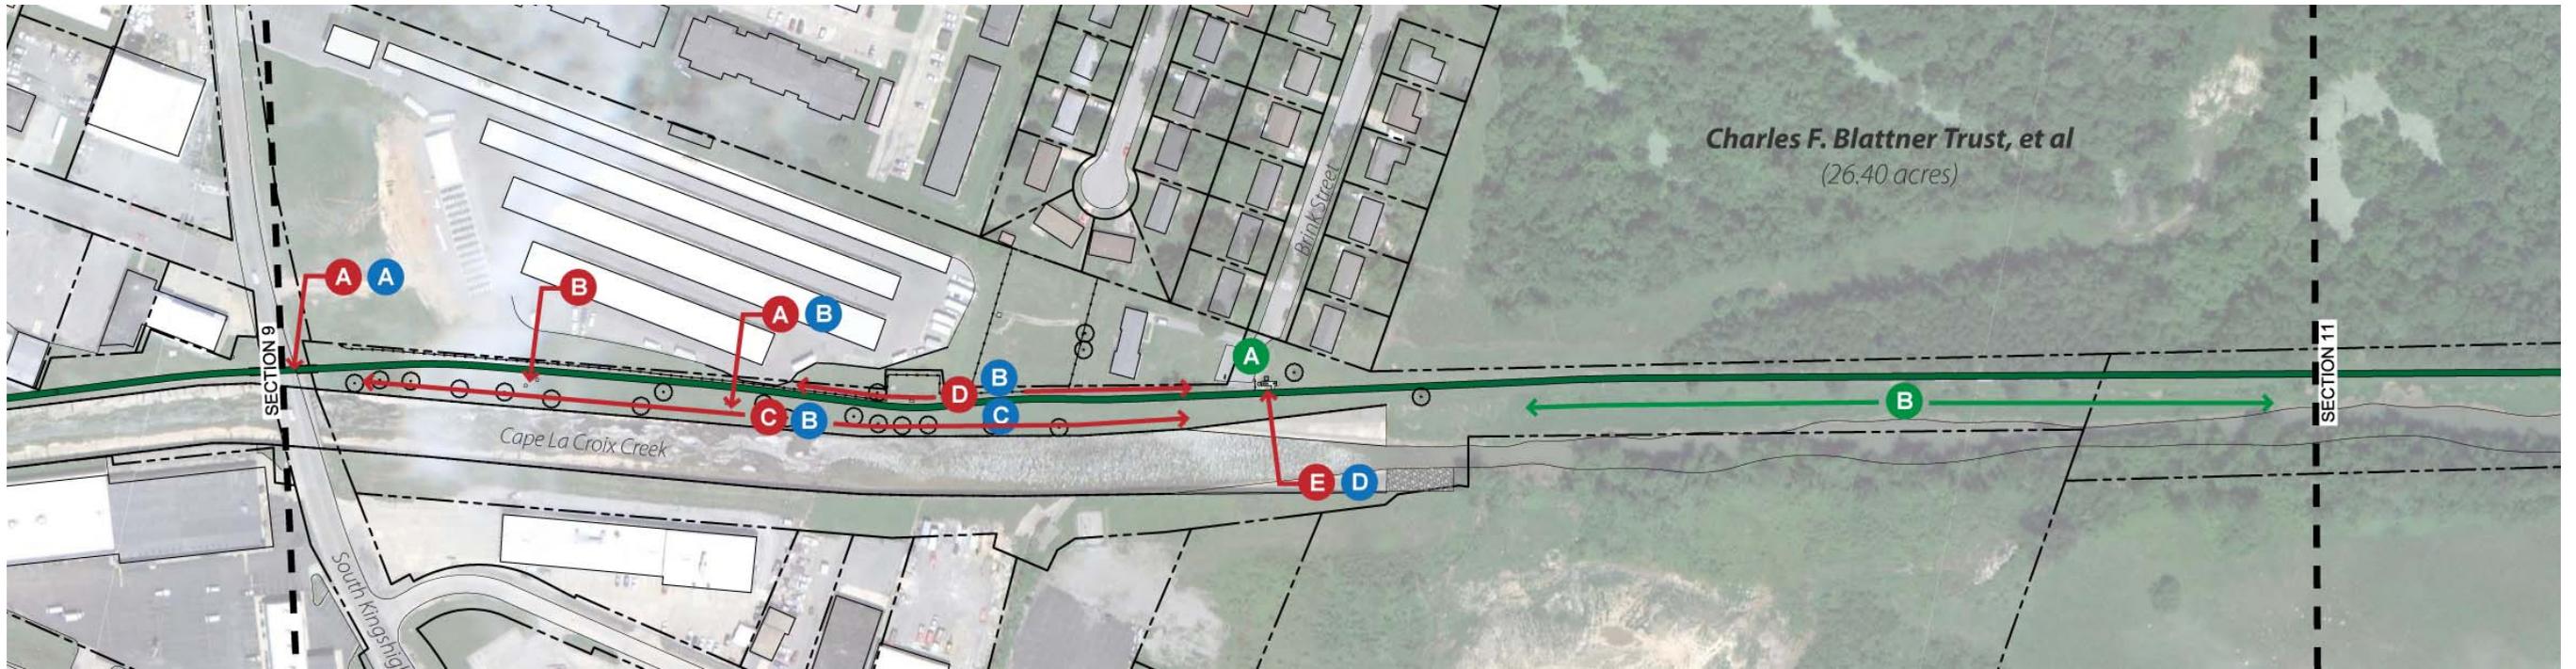
● ATTRIBUTES

- A. Brink Street Trail Head parking lot (5 standard stalls and 0 handicap stalls), temporary restroom facility, drinking fountain, bike rack, park bench, trash receptacle, and trail wayfinding signage.
- B. Natural stream corridor.

● DEFICIENCIES

- A. 8' wide underpass structure - does not meet standard width of 12' and is unattractive.
- B. Sanitary Sewer manhole structures are unattractive.
- C. Industrial development is unattractive.
- D. Storage facility and stormwater detention facility is unattractive.
- E. Parking lot - no barrier between lot and trail; Trail Head - inefficient access and functionality; outdated trail wayfinding signage. ADA access at this location may be restricted due to the slope of the area. Temporary non-ADA compliant portable restroom.

● RECOMMENDATIONS

- A. Use blank concrete wall for painting or public art opportunity. Add signage on South Kingshighway bridge structure for improved orientation. Add lighting for improved perceived safety and trail experience.
- B. Add landscape plant screen to improve quality of trail experience.
- C. Add interpretive educational/informational trail signage.
- D. Add bollards as barrier between parking area and trail. Reconfigure trail head layout to improve functionality, access, and ADA accessibility. Update trail wayfinding signage. Incorporate a permanent, ADA-compliant comfort station in new layout.

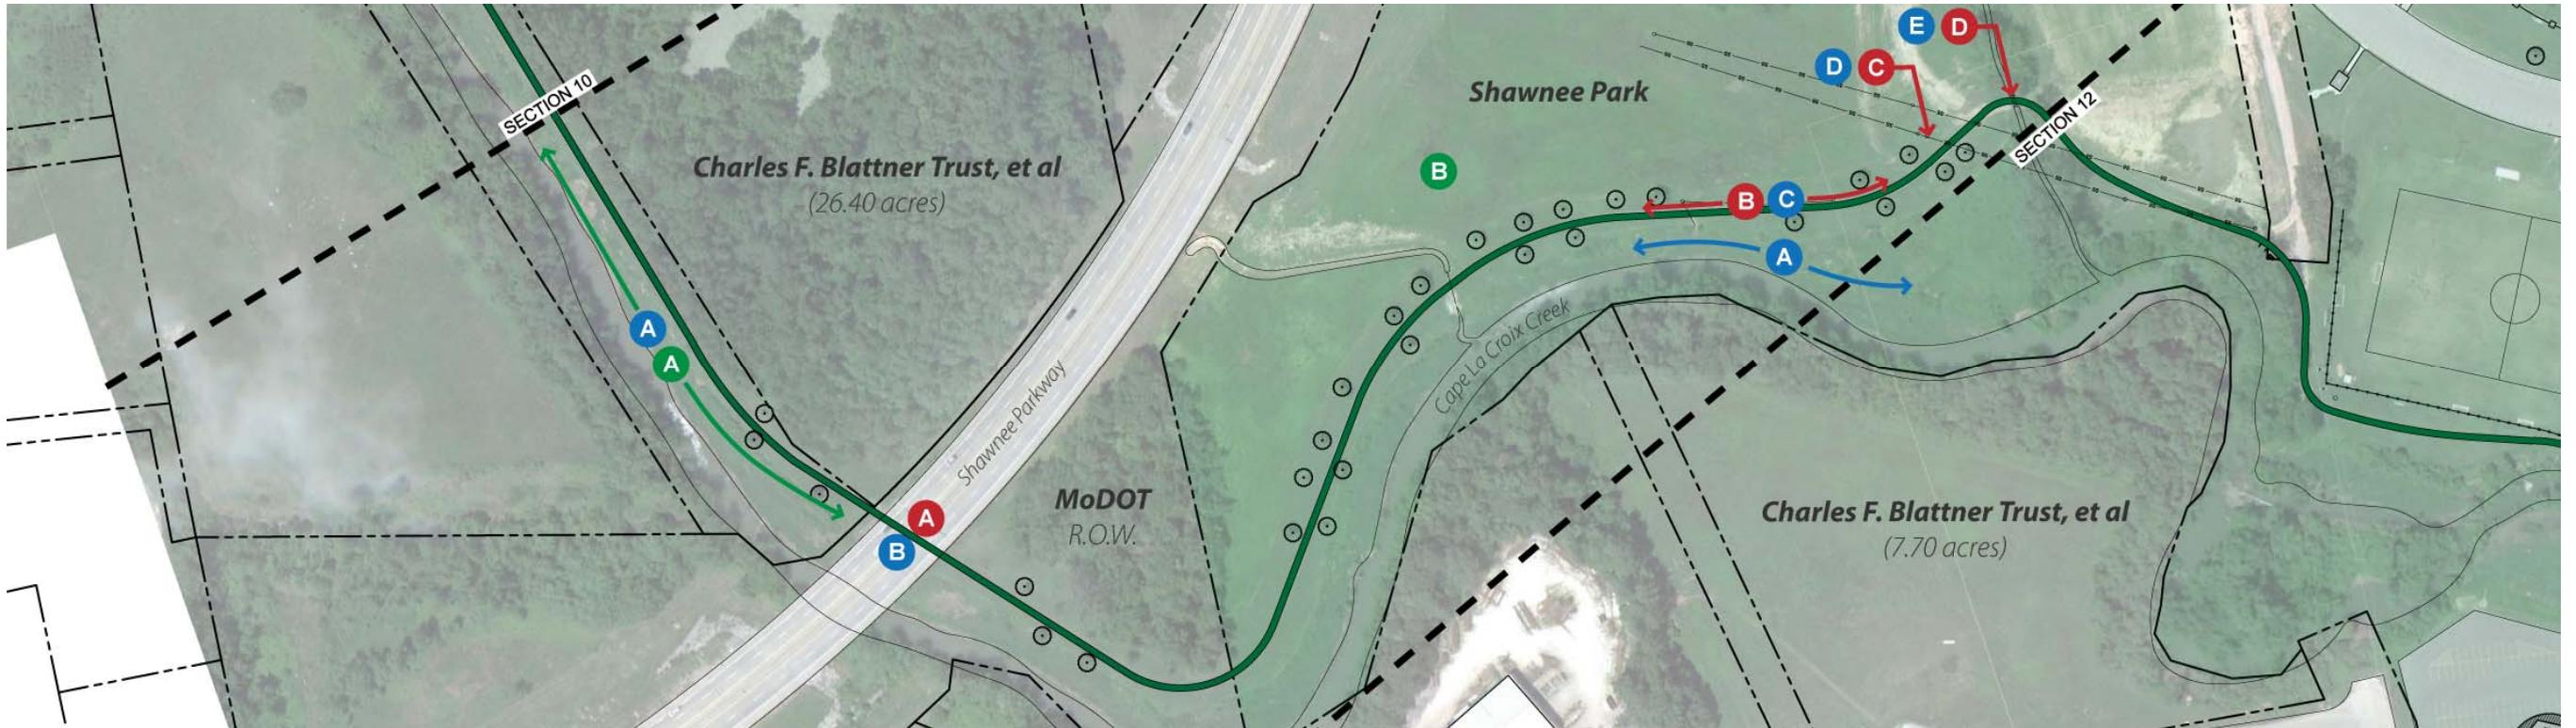
10

● ATTRIBUTES

- A. Natural stream corridor.
- B. Native grass prairie.

- A. Opportunity for interpretive educational/informational signage.
- B. Re-direct Shawnee Parkway storm drains to drain directly to creek and re-distribute rock boulders and incorporate native grass plantings.
- C. Raise trail elevation to allow water to drain across trail towards creek.
- D. Add landscape plant screen to improve quality of trail experience.
- E. Add landscape plant buffer along trail to improve quality of trail experience and trim back existing vegetation to improve sight distance.

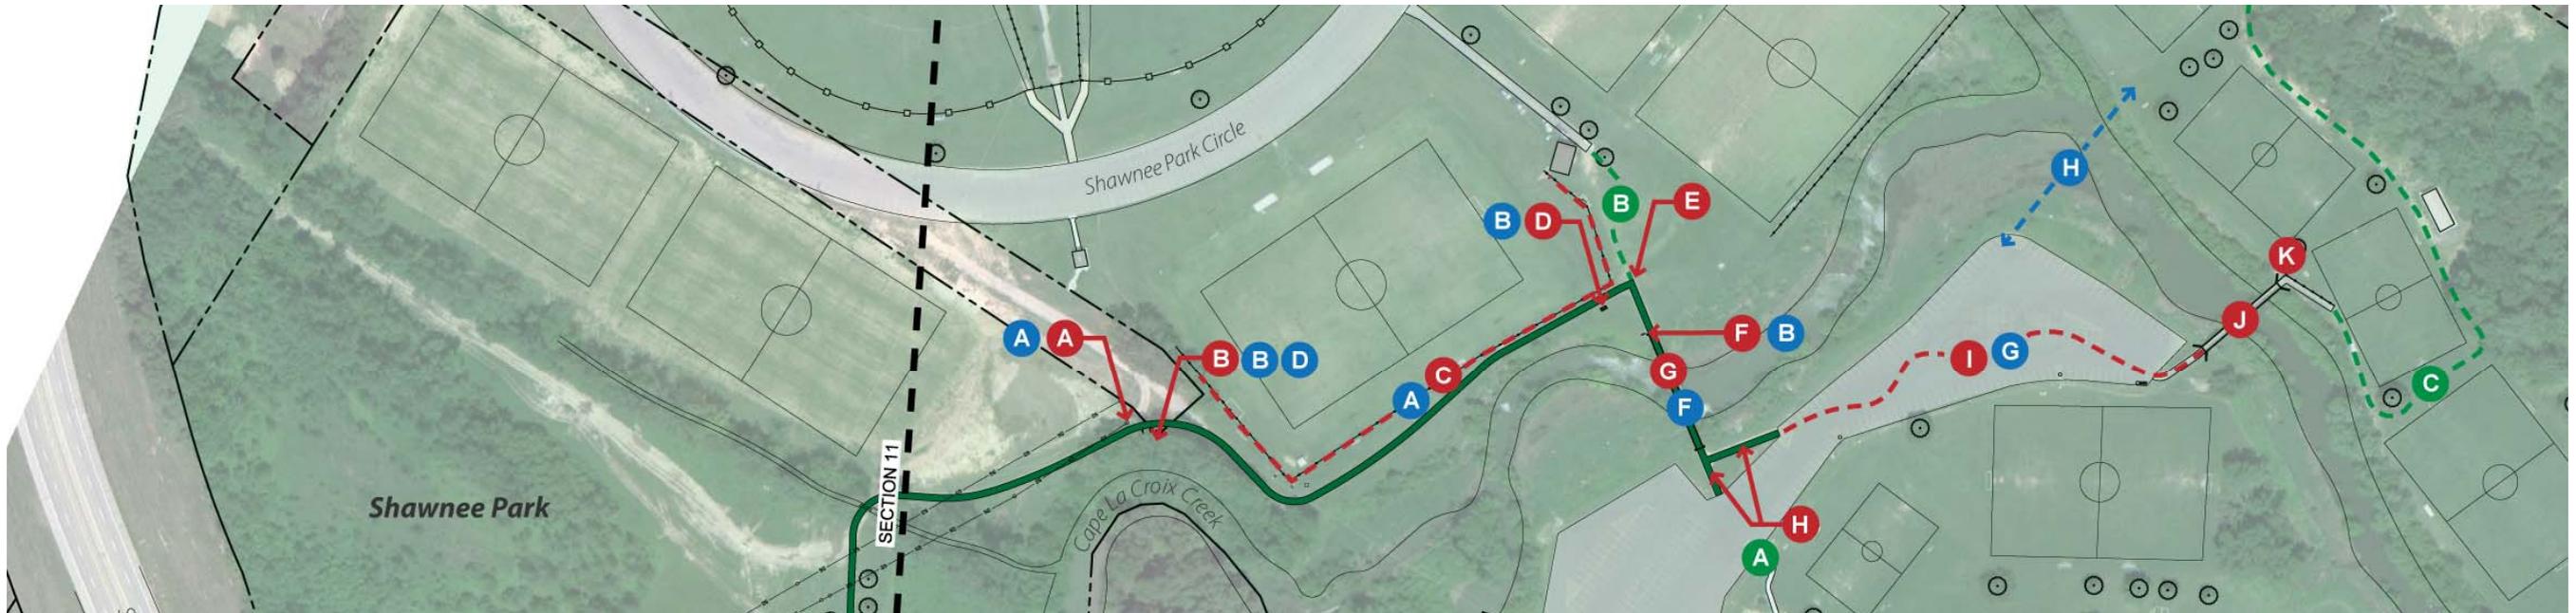
● ATTRIBUTES

- A. Shawnee Park Trail head with concession stand, restrooms, drinking fountain, bike rack, park bench, trash receptacle, and children's playground.
- B. Future access from upper Shawnee Park ballfields to lower southern soccer fields.
- C. Future extension of Cape La Croix Trail to Downtown/Riverfront District.

● DEFICIENCIES

- A. Sanitary Sewer manhole structures are unattractive.
- B. Outdated and non-compliant ADA park bench; outdated trail wayfinding signage.
- C. Sport field fencing is unattractive.
- D. Non-compliant ADA park bench.
- E. 90 degree, sharp curve - does not meet minimum standard design radius of 60'.
- F. Missing bridge warning signage.
- G. Narrow 8' wide bridge structure - does not meet minimum standard design width of 12'.
- H. 6.5%+ trail slope- exceeds maximum standard design slope of 5.0%.
- I. Parking lot - creates un-safe pedestrian and bicycle travel to soccer fields and future Cape La Croix Trail extension.
- J. Narrow 8' wide bridge structure - does not meet minimum standard design width of 12'.
- K. 90 degree, sharp turn does not meet minimum design standard radius of 60'.

- A. Add landscape plant screen to improve quality of trail experience.
- B. Add trail wayfinding signage to improve orientation
- C. Add buffer planting to reduce visual impact of fence.
- D. New ADA compliant bench.
- E. Add trail wayfinding signage and stripe path or change surface material from trail to concession stand.
- F. Future long-term bridge replacement to provide 12' width.
- G. Re-configure parking lot layout with perimeter trail lane to encourage pedestrian traffic to perimeter and re-configure sub-standard parking lot layout.
- H. Future long-term bridge re-alignment - creates shorter length from parking lot to future Trail extension, also improves trail user safety with dedicated travelway.
